Domestic Refrigerator Design – Safety Issues and Opportunities

M Beasley*, PG Holborn**, JM Ingram**, GG Maidment**

Abstract

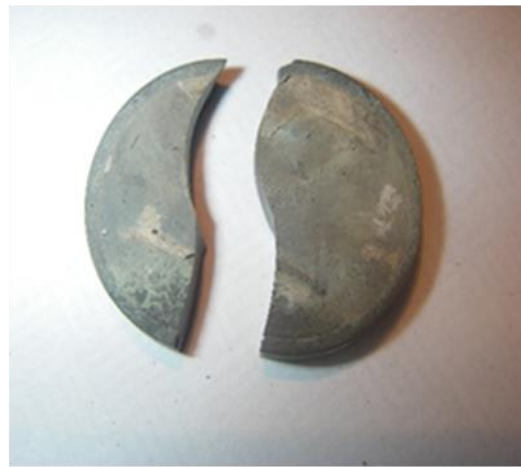
(ii) PTC starter switches

The starter switch normally consists of PTC (positive thermal coefficient) 'pill' housed in a plastic body containing the electrical connections. The pill functions as a conductor until it reaches a temperature (around 120°C) above which it becomes a resistor. Hence the pill functions as a temperature switch. Over time degrading of the pill can occur, until it eventually breaks or splits. Arcing can then take place which is sufficient to melt the metal contacts within the switch.

Figure 1. Examples of ignition sources in refrigeration fires: (a) starter relay; (b) PTC switch; (c) mechanical defrost switch; (d) capacitor.

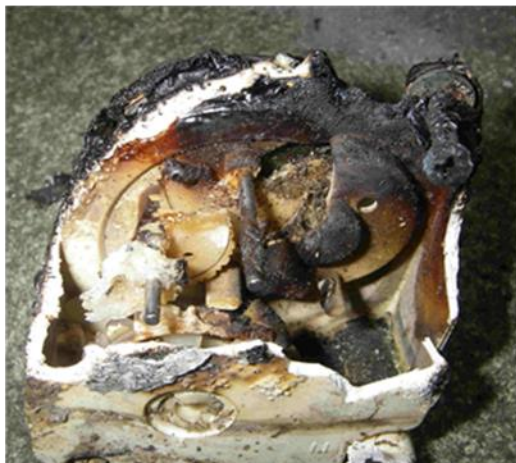
(c)

(iii) Mechanical defrost switch failures

The defrost switch is mounted externally, at the rear of the appliance. The defrost timer housing has a small adjusting hole near its base for manually setting/adjusting the timer. Water penetration into the switch casing can produce severe arcing to the switch contacts. The external switch cover is constructed of fire resisting plastic but the cogs within the switch have a high nylon content and will readily burn. Once the cover has distorted and started to melt, the internal components are then exposed to the atmosphere the switch components will burn and spread the fire to the switch cover and to the appliance insulation.

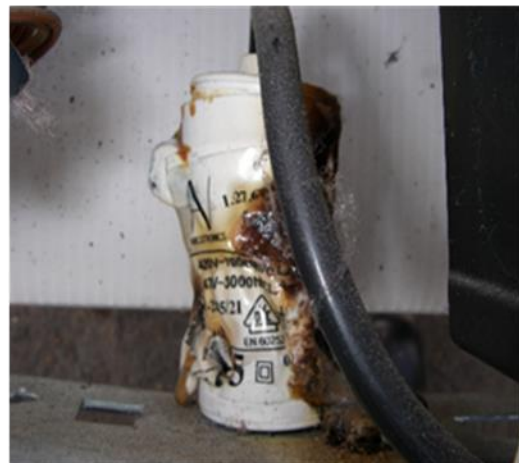
(d)

(iv) Capacitor failures

Capacitors have been fitted to almost all modern refrigeration appliances since around the year 2000. Positioned within the same lower section of refrigeration appliances, its function is normally to either provide a start or run facility which smooths out electrical supply imbalances to the compressor. It is usually located to the left of the compressor although it may also be found mounted adjacent to the compressor start switch. During its lifetime the capacitor will be subjected to various types of stress which can cause it to age and eventually fail, including – over-voltages, over-heating, pollution, humidity, radiation, and vibrations. A capacitor failure can range from a

simple failure of its circuitry leading to a slow melting and degrading to form char, to a dramatic and violent ignition or pressured eruption.
